# **THE CALIFORNIA EARTHQUAKE OF 1906**

The  
California Earthquake  
of 1906

*Edited by*  
David Starr Jordan

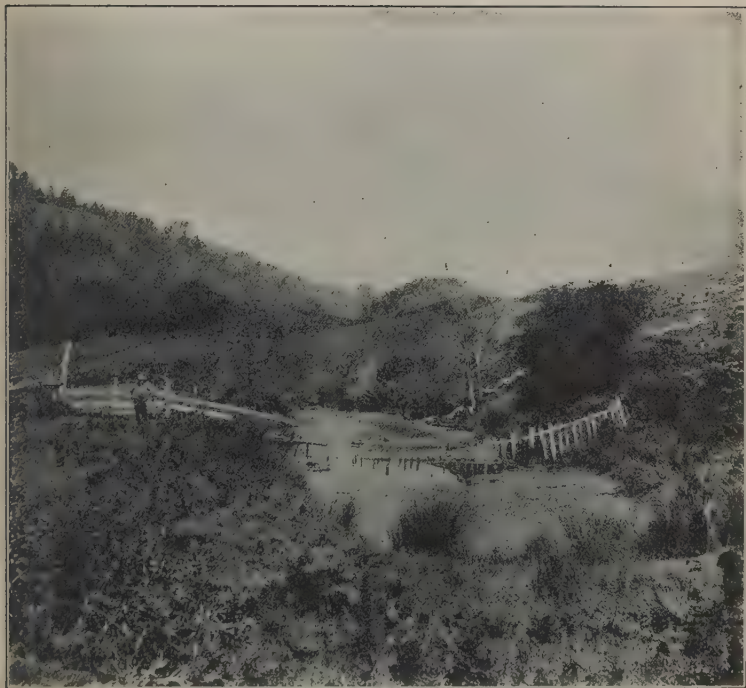
FIG. 2.—Fault Topography between Tomales and Bolinas Bays; Looking Northwest. The General Slope Toward the Left Has Been Interrupted by a Slight Uplift of the Part at the Left. The Pond Occupies a Hollow Thus Produced.

and to obliterate the lakes by cutting down their outlets or filling their basins with sediment. Fig. 2 shows one of the fault-made ponds. This line and zone have been recognized by California geologists through a distance of several hundred miles. It was to this line that attention and expectation were especially directed, and it was on this line that the surface evidence of new faulting was actually found. The new movement was not coextensive with the line as previously traced, but affected only the northwestern portion; and, on the other hand, it extended farther to the northwest and north than the old line had previously been recognized. The map represents only the line along which the recent change occurred. From a point a few miles southwest of Hollister it runs northwestward in a series of valleys between low mountain ridges to the Mussel Rock, ten miles south of the Golden Gate. Thence northwestward and northward it follows the general coast line, alternately traversing land and water. The farthest point as yet definitely located is at Point Delgada, but the intensity of the shock at the towns of Petrolia and Ferndale probably indicates the close proximity of the fault and warrants the statement that its full length is not less than three hundred miles. South of Point Arena its course is direct, with only gentle flexure, but the data farther north

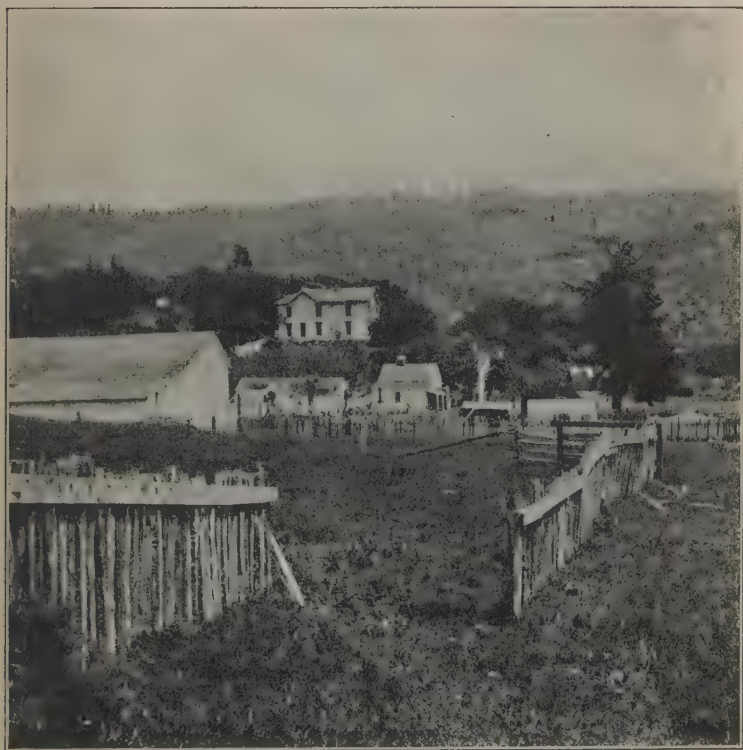
FIG. 3—This Fence, Previously Continuous and Straight, Was Broken and Parted by the Earthquake Fault, the Offset Being  $8\frac{1}{2}$  Feet. The Line of Fault, Concealed by the Grass, Crosses the Ground from Left to Right, Touching Both the Dissevered Ends of the Fence.

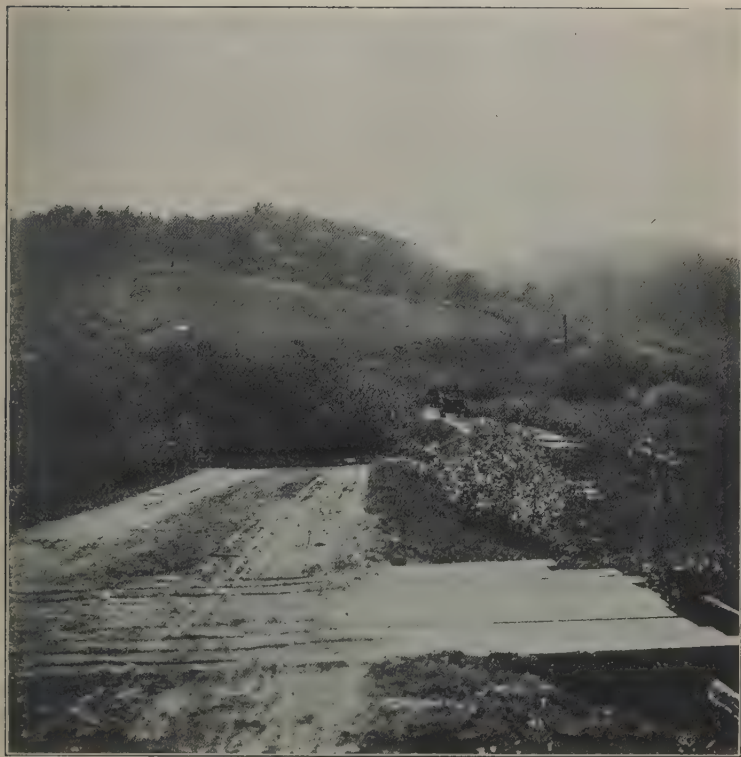
FIG. 5.—A Faulted Road near the Head of Tomales Bay. The Nearer and More Distant Parts of the Road Were Originally in One Line—a Continuous, Straight Road. The Present Offset is Twenty Feet.

of about 10 feet. At one place (Fig. 5) a road was offset 20 feet, but in this case the underlying ground was wet alluvium and part of its movement may have been due to a flowing of the soft material. There was also some vertical change, but this was not everywhere in the same direction and its amount was comparatively small. At many points the land west of the fault appears to have risen one or two feet as compared with the land at the east.

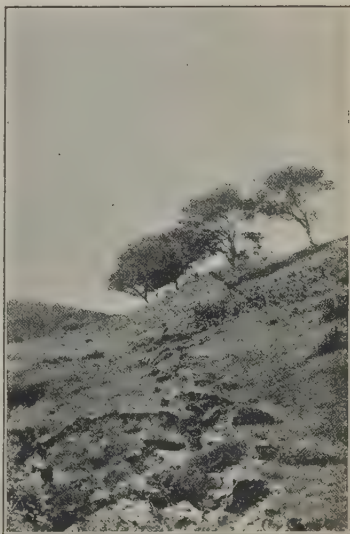
FIG. 6.—*Ordinary Appearance of the Earthquake Rift Where It Traverses Firm Turf.*

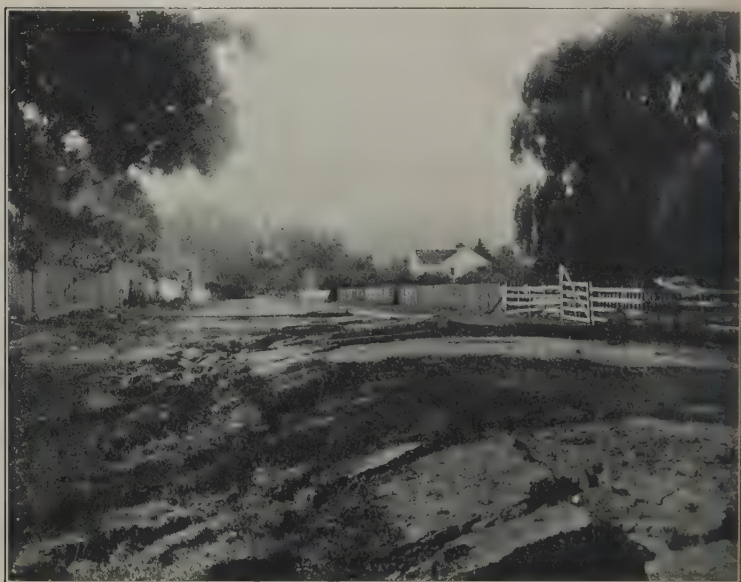
FIG. 7—A Zone of Earthquake Fracture Where It Crosses a Road Near Bolinas.

angles and gradually dying out in the adjacent country, and in some of these the belt of disturbance is broad and complicated (Fig. 7). There are also outlying cracks occurring within a mile or two of the central rift and having irregular courses, and these may probably be referred to the same general system of rock strains.

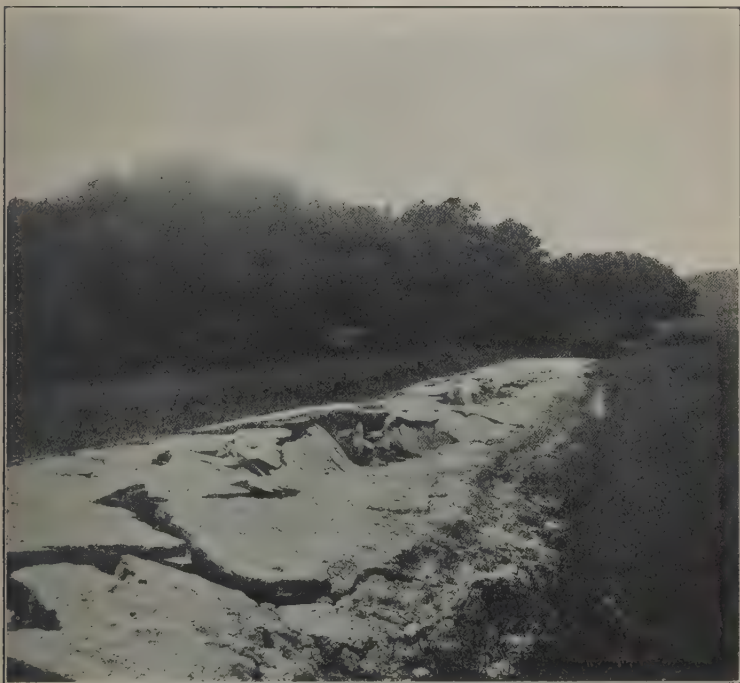
FIG. 8—Cracks Caused by the Shaking of Marshy Ground. The Comparatively Firm Road Embankment Preserved the Cracks Better than the Bog.

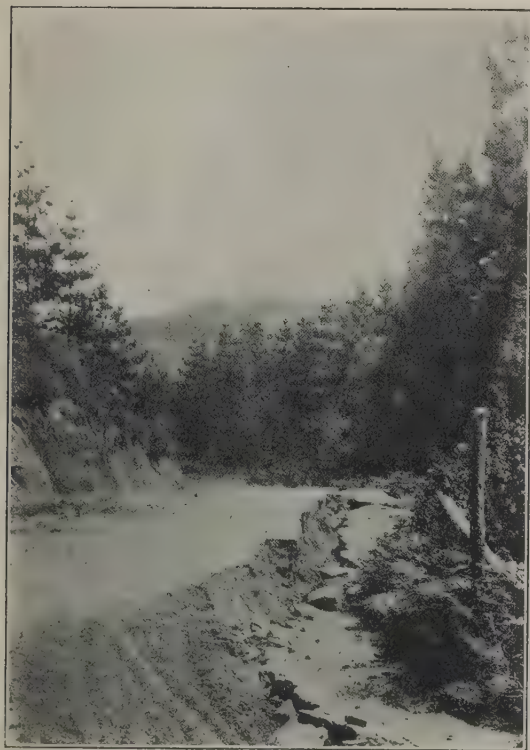
FIG. 10.—Road Crack Caused by the Earthquake.

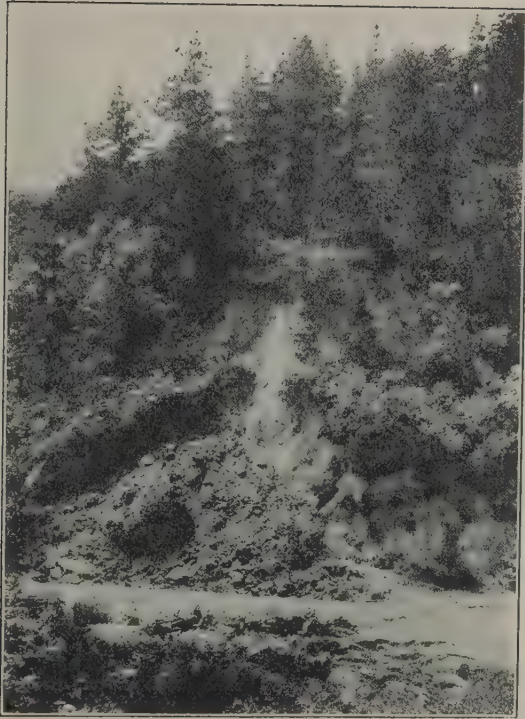
Certain changes, very conspicuous to the observer who drove about the country, are closely associated with roads. A side-hill road is usually constructed by excavating a notch in the natural slope and piling the excavated material in an embankment at the outer edge of the notch. In course of time, and especially during rainy seasons, the embankment at the outer edge of such a road settles and has to be built up as a matter of repair. Portions of the bluff on the up-hill side of the notch are also apt to fall away, taking the form of small landslides, which have to be removed from the road as a rule after every rainy season. The earthquake precipitated many changes of this sort. Along all side-hill roads in the immediate vicinity of the rift a crack was developed between the embankment and the original soil against which it rested, and this crack often assumed formidable dimensions (Fig. 10); in fact its magnitude was found to be a convenient index of the local violence of the earthquake in regions where buildings are rare. Landslips from the bluffs margining the roads (Fig. 11) were also very numerous, in many instances

FIG. 11—*Small Landslide on the Uphill Side of a Side-Hill Road.*

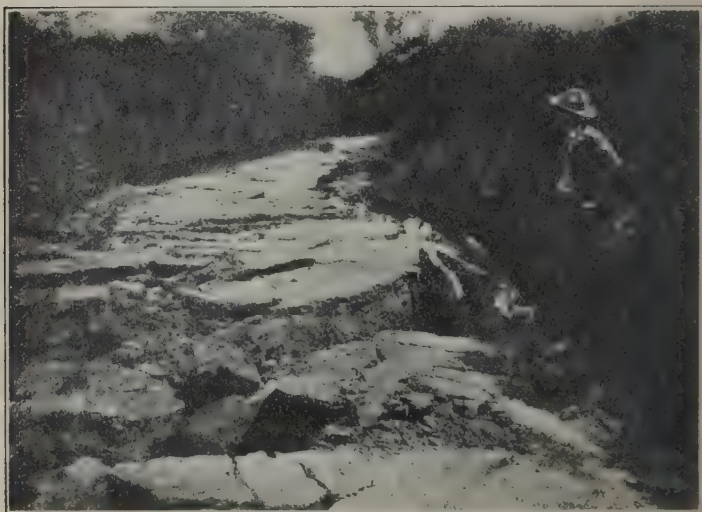
FIG. 3—Road Crossing the Fault Line Two Miles Southeast of Portolá. There Is a Vertical Uplift on the Northeast Side of the Fracture at This Place.

northeast, or a small downthrow on the southwest, or both. The lateral displacement is well defined, as far as it has been traced, and at some points amounts to as much as 9 feet. The vertical displacement in most places is not so evident, but about a mile southeast of Portolá there is an uplift

of 2 feet on the northeast side, and the same amount of vertical displacement has been observed on Black Mountain.

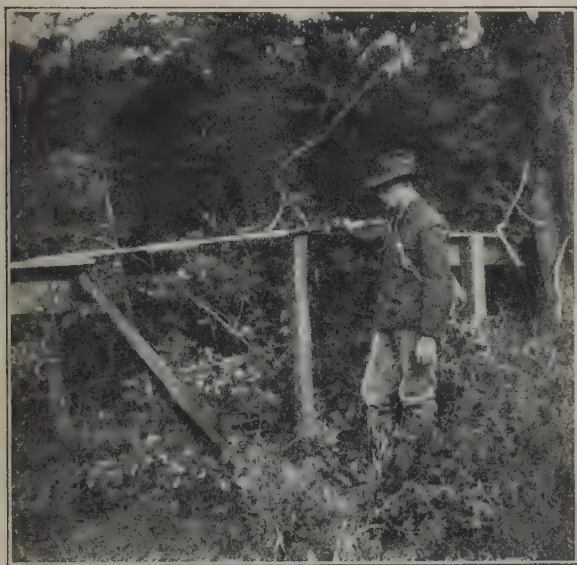
FIG. 4—Showing a Fence That Crossed the Fault at an Oblique Angle. The Post Shown in the Photograph Was Split and Pulled Apart and the Wires Broken.

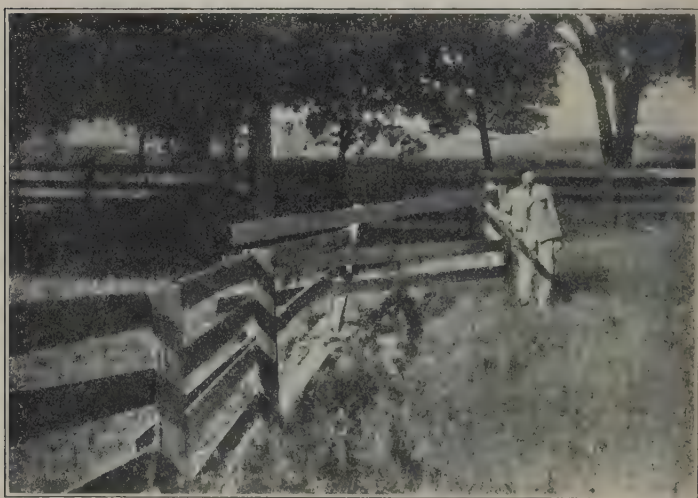
FIG. 5—Showing a Fence That Was Broken and Offset Eight Feet Where It Crossed the Fracture.

Black Mountain was badly shattered, and there are numerous cracks running over it in all directions. Fences crossing the fracture are broken; those that run in a north-and-south direction have their boards bent into arches or crushed, and the ends shoved past each other, while those that cross in a northwest-and-southeast direction have been pulled apart, and wire fences have been broken by tension. Fences that cross the fracture at right angles have been broken and displaced 8 or 9 feet.

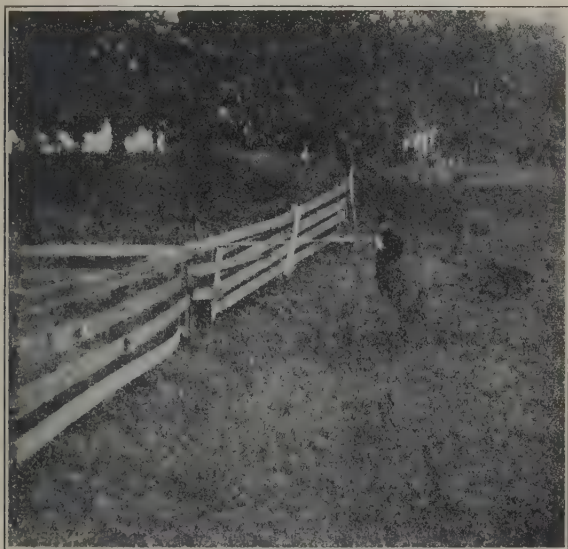
FIG. 6—*Photograph of a Fence Crossing the Fault-Line at Right Angles. The Man is Holding an Eight-Foot Transit Rod and Stands in Line with Continuation of the Fence on the Far Side of the Fracture. The Fence Was Repaired Before the Photograph Was Taken.*

The photograph (Fig. 6) shows a line fence crossing the fault a mile southeast of Woodside. This fence was broken and displaced over 8 feet, but had been repaired before the photograph was taken. The man at the right in the picture is holding an 8-foot transit rod, and he is standing in line with the continuation of the fence on the far side of the fracture. The crack crosses the fence just back of where he is standing.

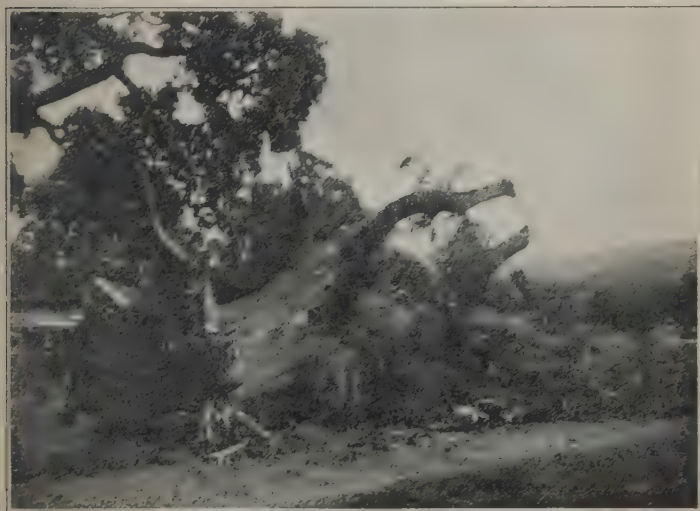
FIG. 8—An Oak Tree Six Feet in Diameter Uprooted by the Earthquake Three Hundred Yards from the Fault Line.

The intensity of the shock was greatest along the line of faulting and decreases as one goes away from this line. In comparing the intensity of the shock at different places, the best evidence was supplied by the oak trees broken and uprooted where the intensity was greatest, by the percentage of country water-tanks thrown down, and, as the intensity decreased, by the condition of plastering in houses and the number of brick chimneys found standing.

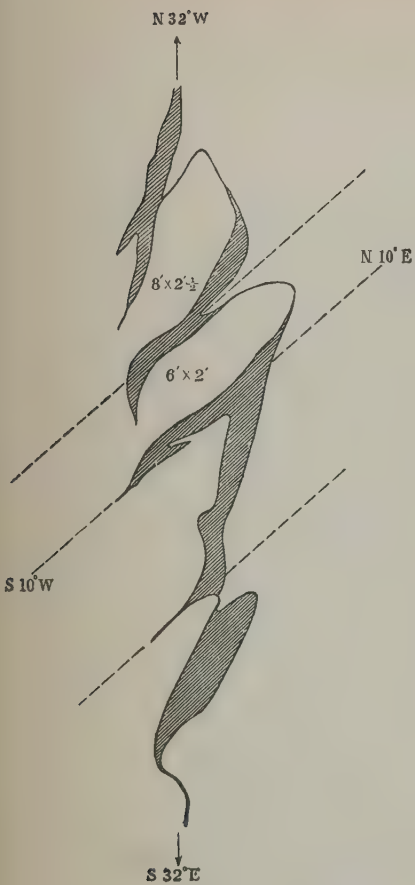
Figs. 8, 9 and 10 show parts of the fault lines found near the town of Manchester, not far from Pt. Arena; the dotted lines in each figure indicating the directions of the secondary shear cracks. Fig. 8 is the plan of the remarkable disturbances shown in Fig. 13. In Figs. 9 and 10, the angle between the main fault line and

the shear cracks varied between  $44^{\circ}$  and  $47^{\circ}$ . In Fig. 8, however, there was evidently a very strong compression, and the shear angle was smaller, namely,  $42^{\circ}$ .

FIG. 8.—The Shaded Parts Indicate Cracks of the Ground.

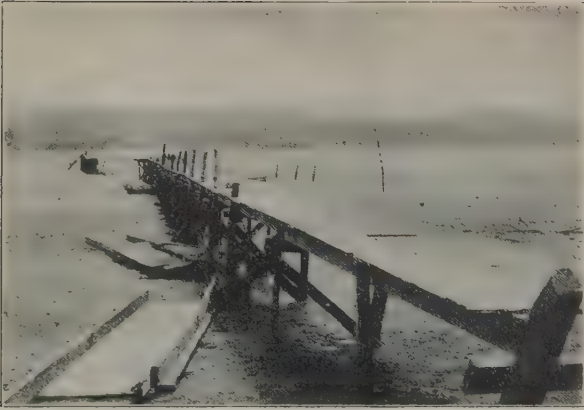
Fig. 11 (Pl. III) shows the shearing effects on a pier at Inverness, on the west coast of the Tomales Bay. The end part of the pier was separated from the rest and was displaced about 20 feet toward NNW. The direction of displacement in this particular instance was opposite to the general direction of the relative slip along the great fault line.

FIG. 11—The Shearing Effects on a Pier at Inverness, on the West Coast of the Tomales Bay. The End Part of the Pier Was Displaced About 20 Feet Towards NNW.

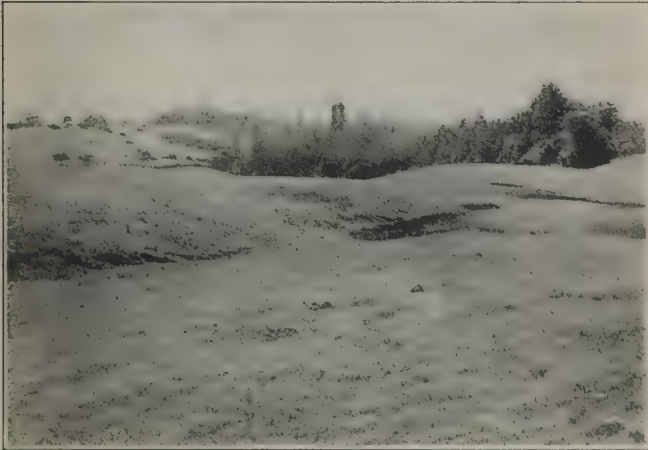
Fig. 12 (Pl. III) shows one of the fault cracks produced among the hills above Fort Ross. It will be observed that the new disturbances appeared along a depression marked by a series of small ponds (shown at the right-hand side of the cut),

FIG. 12—One of the Fault Cracks Produced Among the Hills Above Fort Ross. The New Disturbances Appeared Along a Depression Marked by a Series of Small Ponds (Shown at the Right-Hand Side of the Picture), Which Are Traces Left by a Former Earthquake.

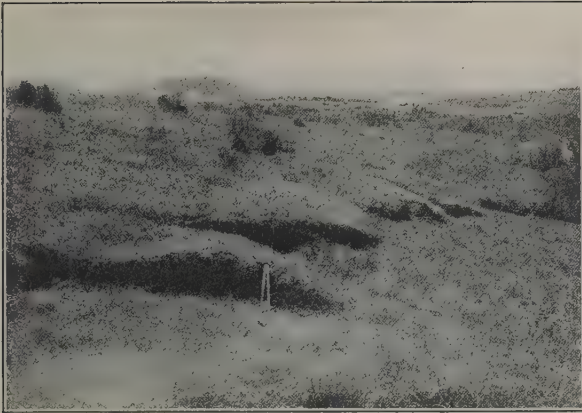
FIG. 13—Remarkable Compression and Shear Effects Along One of the Fault Cracks, Produced on Elevated Grounds Near Pt. Arena. A Foot-Scale Placed in the Foreground Shows the Size of the Overlapping Earth Pieces, Whose Plan Is Given in Fig. 8.

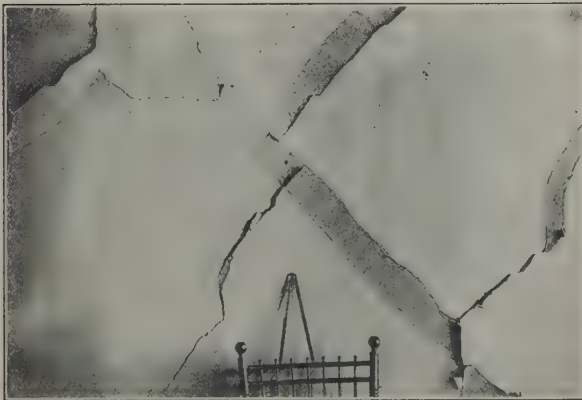
Fig. 14 (Pl. IV) illustrates some of the cracks of plastered walls observed in St. James Hotel, San José.

FIG. 14—Some of the Cracks of Plastered Walls, in St. James Hotel, San José.

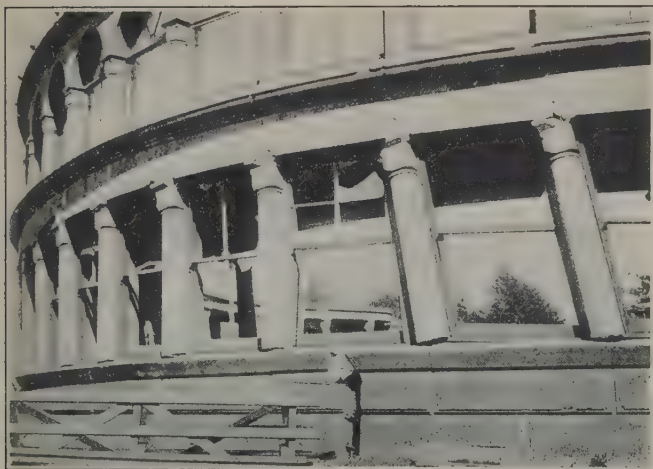
Fig. 17 (Pl. VI) gives an outside view of the back part of the Observatory on the top of Strawberry Hill, in the Golden Gate Park, San Francisco. This building is of reinforced concrete and furnishes a good demonstration of the strength of such structures. The Observatory was indeed seriously damaged and its front portion fell down to the ground, but this was on account of the weakness of the foundation ground, which was mostly a filled-up one and was considerably cracked and depressed. Fig. 18 shows, in a larger scale, one of the cracks of the basement wall, similar to that shown in Fig. 17. The steel cable, one inch in diameter, which was embedded in the concrete, was broken. The use of steel cables in concrete walls thus seems to be objectionable, as they are more liable to rusting than solid steel bars. None of the latter used in the concrete walls and floor of the Observatory, whose section was half inch square, was found broken; the adhesion of concrete and steel being also very good.

FIG. 17—The Observatory on the Top of the Strawberry Hill, in the Golden Gate Park, San Francisco, Built of Reinforced Concrete. An Outside View of the Back Part.
